NATIONAL TRANSPORTATION SAFETY BOARD

MATERIALS LABORATORY FACTUAL REPORT

Report No. 06-021

Place : Lake George, New York
Date : October 2, 2005
Vehicle : Small passenger vessel "Ethan Allen"
NTSB No. : DCA06MM001
Investigator : Brian Curtis

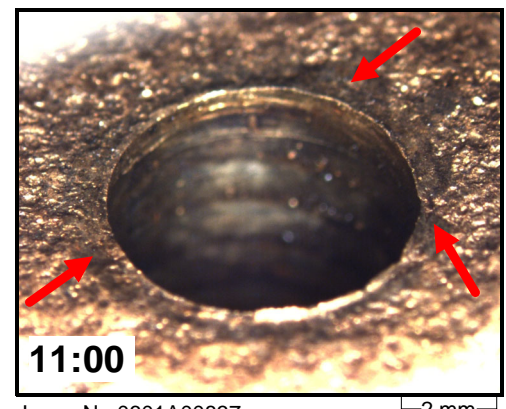
Figure 7. The bearing housing contact faces for the 7:00 lock washer (left) and for the 11:00 lock washer (right).

The lock washer for the 7:00 bolt would normally be in contact with the bearing housing surface illustrated in the left view of figure 7. The yellow arrow indicates a distinctive straight indentation, with material forced forward in the direction indicated by the arrow, which could be produced by the loosening off of a helical spring lock washer. The red arrows indicate a slight flattening of isolated locations on the dimpled surface.

The spring washer for the 11:00 bolt would normally be in contact with the bearing housing surface illustrated in the right view of figure 7. No distinctive indentation was observed, and the red arrows indicate a slight flattening of isolated locations on the dimpled surface.
